ARMY RESEARCH LABORATORY

Unique Aspects of Micromechanics in Ballistic Penetration

ARL-TR-1412

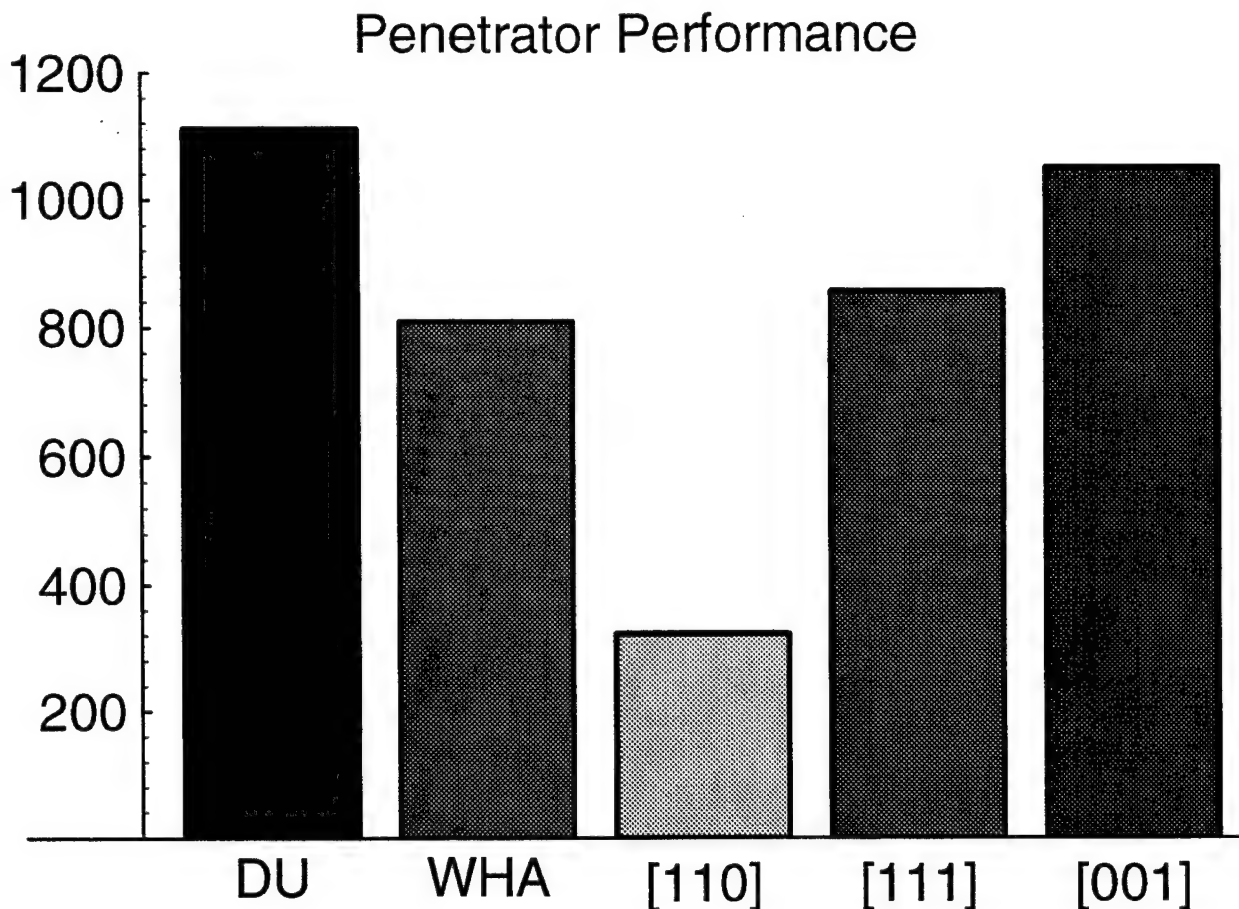
Figure 1. Results of Ballistic Tests Against Semi-Infinite RHA.

The ballistic experiments have been described previously [1]. Figure 1 graphically summarizes the results. Each crystal rod had a selected unique crystallographic direction parallel to the penetrator axis. The observed results are a strong function of crystallographic symmetry, and in contrast with quasi-static stress-strain tests, the $[111]$ (three-fold symmetry axis) single crystal was not the best performer. The $[001]$ (four-fold symmetry axis) rod actually exceeded current tungsten heavy alloy penetrators and approached the performance of depleted uranium [1].

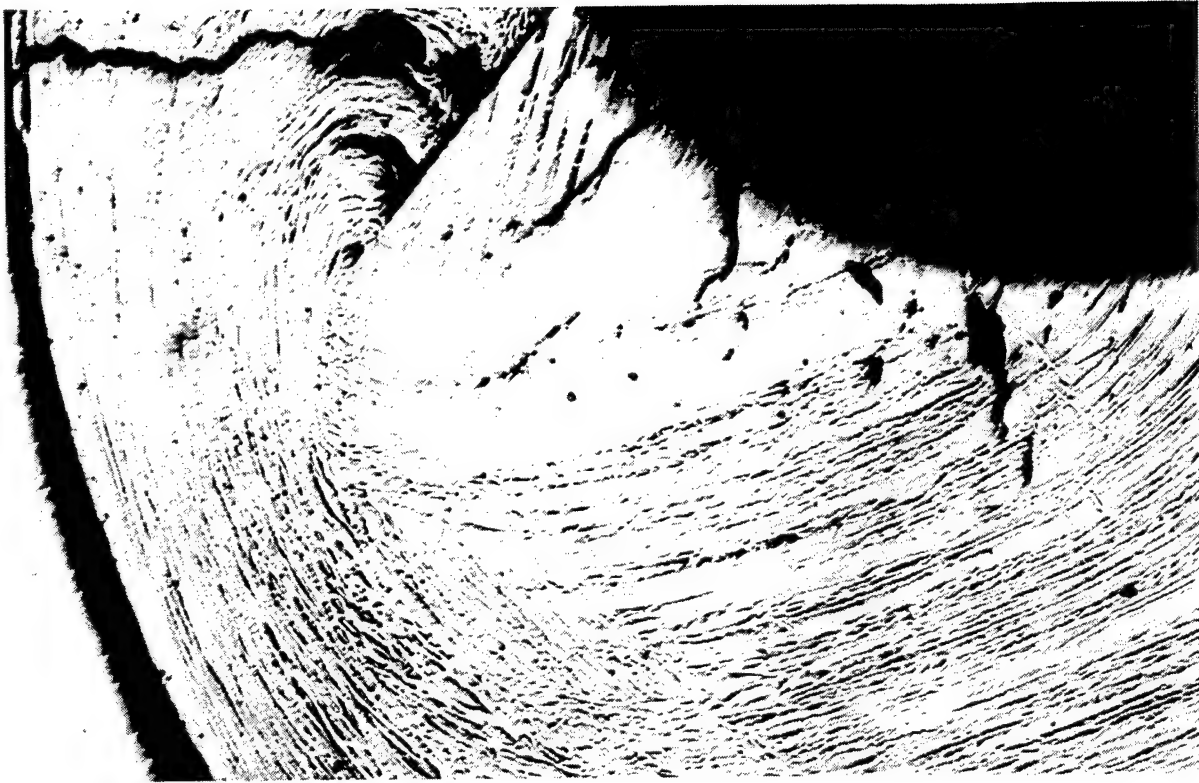
Figure 2. Axial Section of [110] Penetrator, Showing Remnant Crystal and Flow Pattern.

3.1 [110] Penetrator. This residual penetrator was completely recrystallized except for a small region at one corner of the back end (Figure 2). The material in the etched band structure is polycrystalline, and the Debye-Scherrer (D-S) rings from various regions indicated a variety of substructures ranging from sharp, equiaxed recrystallized grains to broad cold-worked rings, generally with strong texture. The rear surface of the rod was a mass of irregular surfaces, implying that the residual rod was heavily cracked and fragmented. The small remaining crystal fragment was tilted and deformed, so no useful orientation information could be obtained. The bands and cracks (probably originally axial) in the upper right portion of Figure 2 are thought to have initiated early in the process, followed later by laminar flow with extensive recrystallization. Although verification by diffraction was not possible, the appearance of the bands suggests twins, which would agree with observations by other workers [3, 4]. Figure 3 is a scanning micrograph of the layered structure in the extrusion tube. Some layers consist of relatively equiaxed grains and intergranular fractures, while the middle layer contains an extended region of cleavage. This microstructure agrees well with the flow pattern seen in Figure 2: some lamellae, possibly twin bands, developed a textured substructure which cleaved, while the surrounding material eventually recrystallized into equiaxed grains, resulting in intergranular fracture. The varied structure and appearance of the D-S rings in X-ray diffraction patterns from

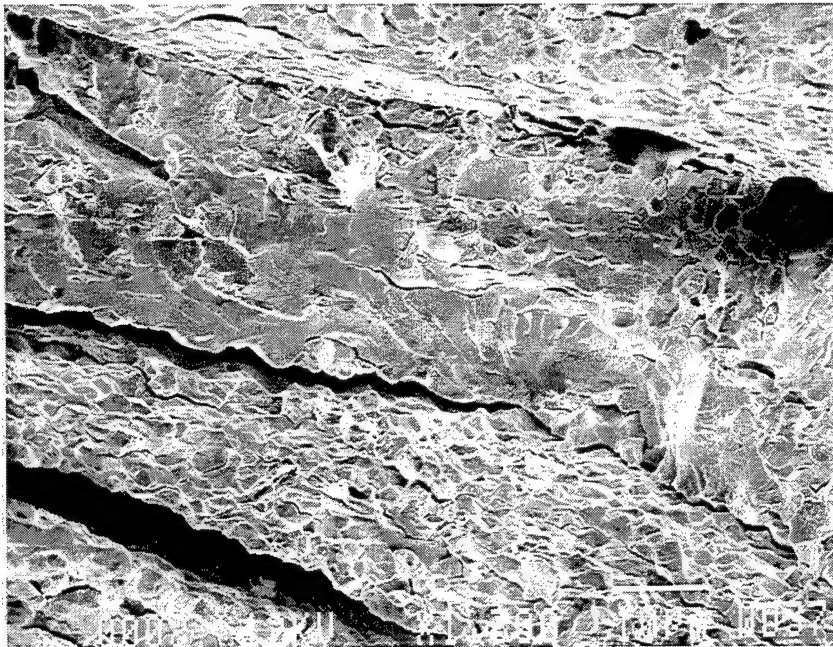
Figure 3. Layer Structure in Extrusion Tube of [110] Penetrator.

this residual also support that interpretation. The overall flow patterns and general appearance of the [110] extrusion tube are quite different from those of other orientations. The frond-like shape of the foliations suggests extensive ductile flow at this stage of the process (Figure 4).

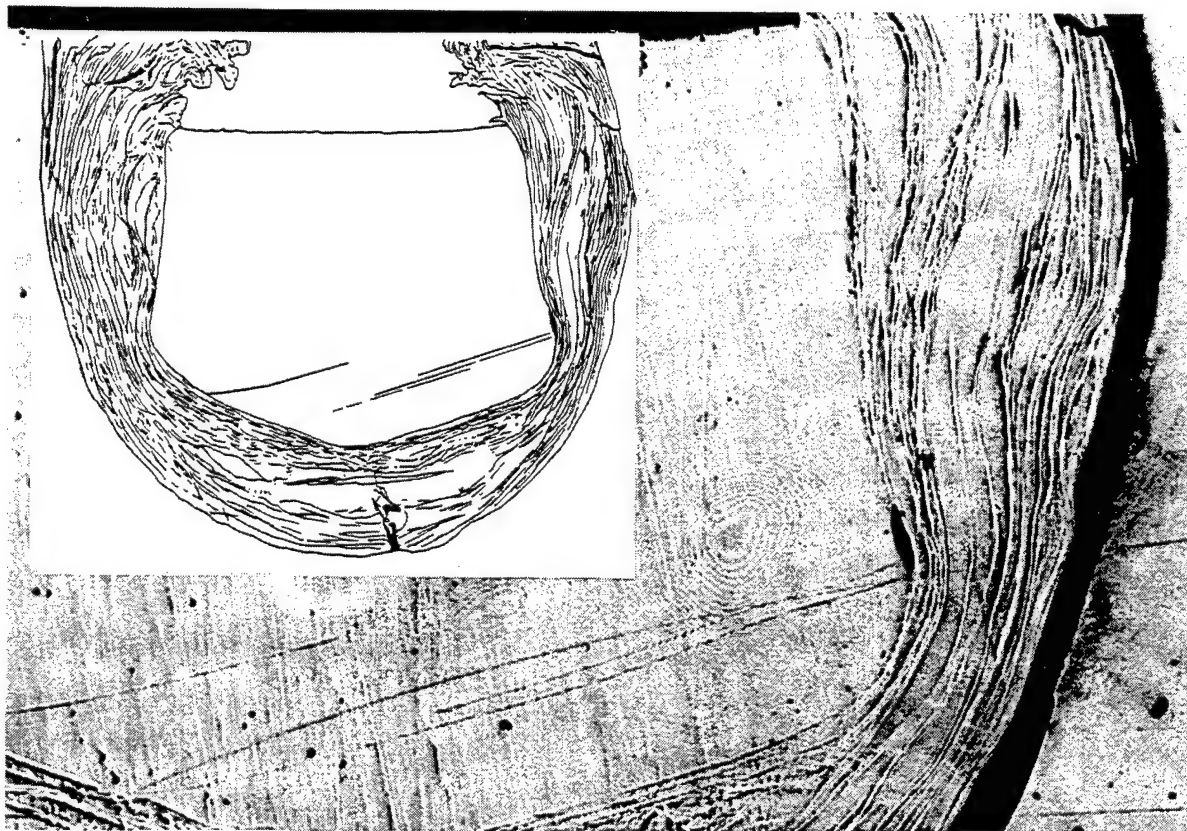
Figure 5. Axial Section of [111] Penetrator: Flow Line Patterns and Internal Bands Near Lower Right Corner. Inset: Schematic of Residual.

3.2 [111] Penetrator. An axial section through the [111] residual penetrator is shown in Figure 5. Diffraction patterns showed that the well-defined, blunt-nosed residual rod (schematic inset in Figure 5) is a single crystal, with some uniform lattice distortion but little net lattice rotation. Material in the flowed regions was primarily polycrystalline, with some lamellar bands surrounded by regions of equiaxed recrystallized grains. A few relatively large lamellae, mostly embedded directly ahead of the residual rod, were still single crystals, although severely bent and deformed. These regions appear schematically below the residual crystal in the Figure 5 inset. Figure 6 shows a series of diffraction patterns from the largest crystal fragment. As a reference, the X-ray pattern at point (a) is typical of the main body of the residual rod. Diffraction patterns from points (b), (c), and (d), all within the largest fragment, showed heavily textured rings along with broad, structured discrete reflections. The crystal orientation changed continuously from point (b) to point (d). It appears that the separated segment was in the process of being forced out of the way of the oncoming rod, surrounded by material previously recrystallized.

The precise nature of the few narrow bands appearing in the residual crystal could not be determined, but close examination suggests that they are flow bands whose propagation separates a crystal segment from the main rod. In the micrograph of Figure 5, a pair of closely spaced bands appears in the lower right corner. On the far right are layers of material that has already been discarded and forced out of the path of the rod. Just above the tip of the band is a small void between the rod and the discarded material, possibly opened up as the segment in the process of discard began to move to the right. We can infer that the segment below the band is just beginning to separate, the deformed and partially recrystallized region embedded directly below the rod resulted from a preceding discard, and the entire continuous layer of material surrounding the residual and extending to form the hollow tube is the result of a succession of such events.

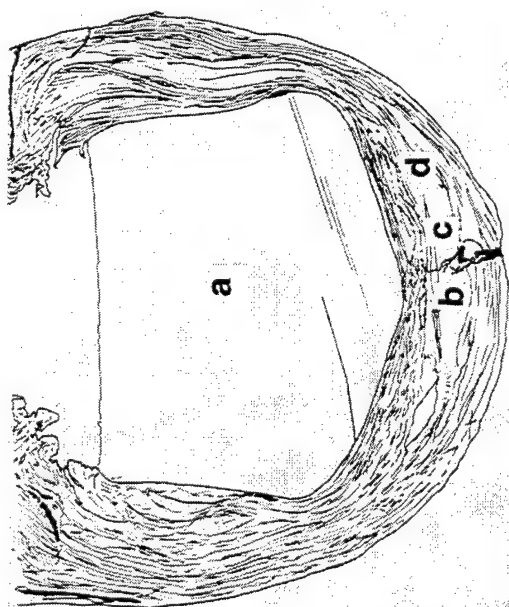
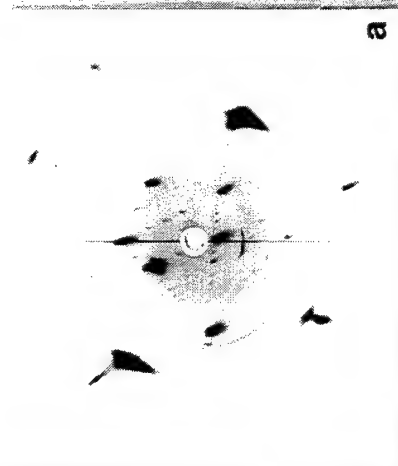
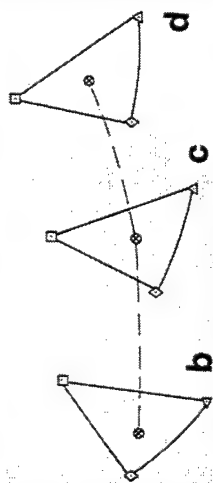
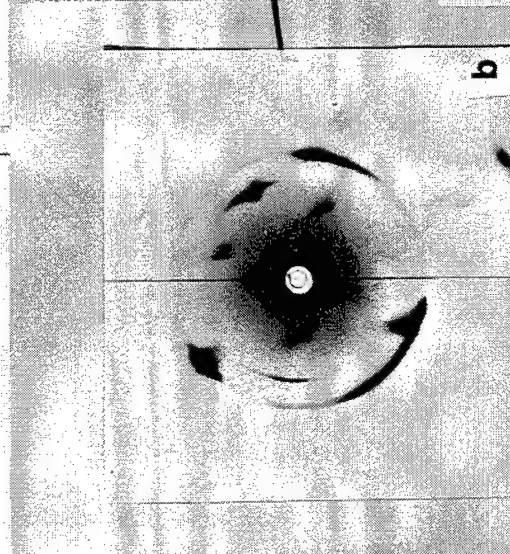
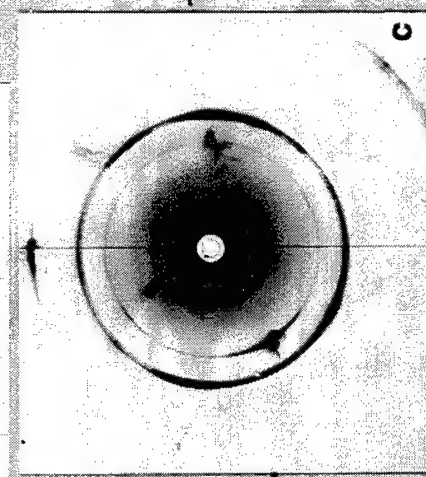
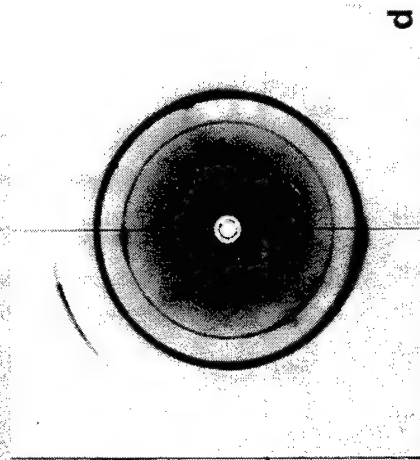
Figure 6. X-ray Analysis of Separated Crystal Segment Ahead of the $[111]$ Residual Rod.

(Right) Reorientation of separated single crystal segment during radial flow at front of penetrator.

(Above) orientation of observation surface.
(Left) Diffraction pattern from center of $[111]$ residual rod (location a).

Diffraction patterns from locations a), b), c), in single crystal fragment embedded in flow ahead of remanent residual rod.

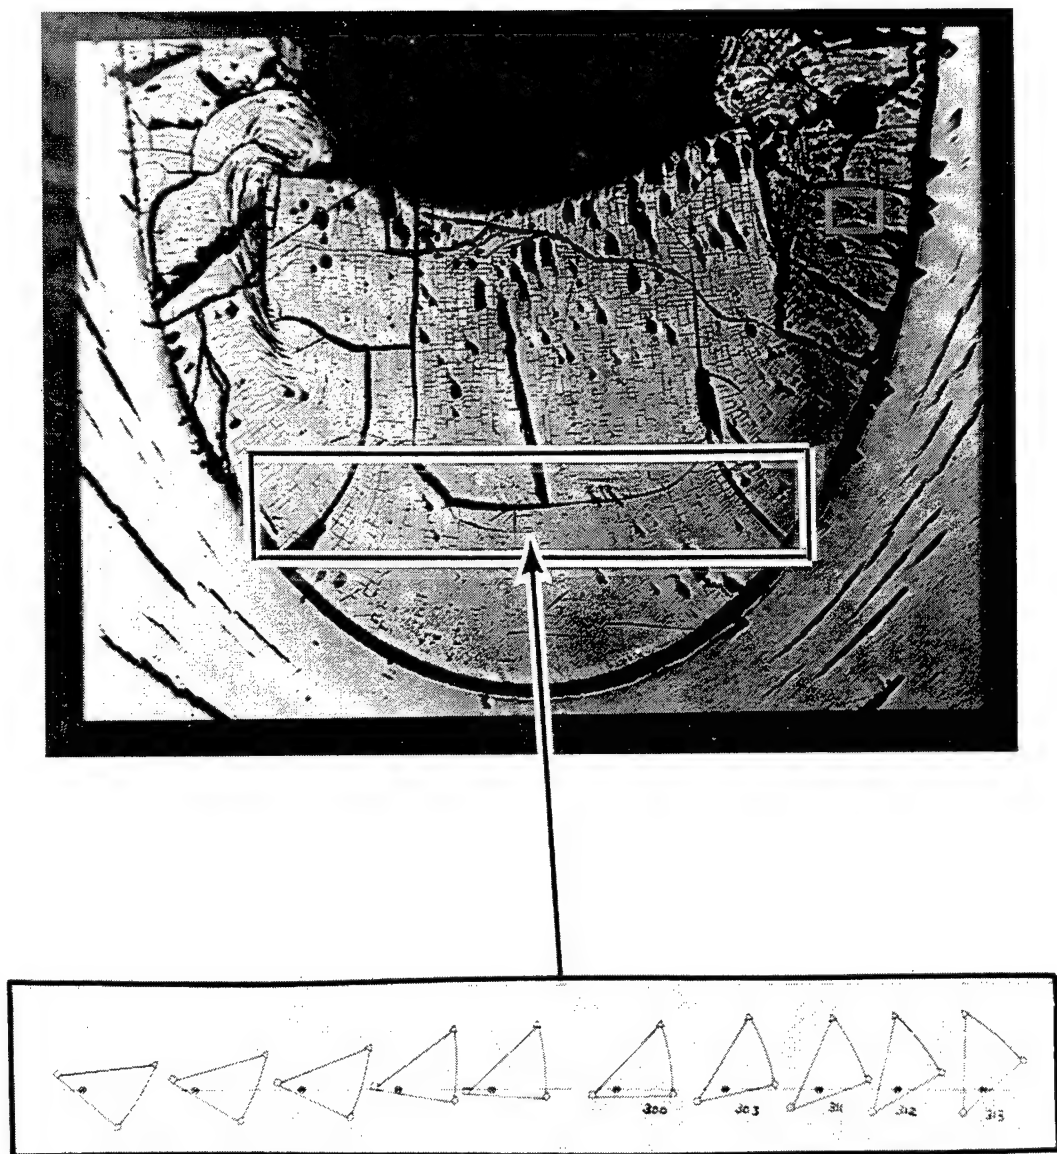
Figure 7. Stereograms of Diffraction Patterns Taken in Sequence Across [100] Peripheral Flow Region.

In the upper right corner of Figure 7, the microstructure appears inconsistent with the remainder of the sample, since the crack network is not evident. This region is shown in more detail in Figure 8a. X-ray analysis showed that above the severe inhomogeneity occurring adjacent to the residual rod, the lattice orientation abruptly changes by about 30° , so that the (001) cleavage plane is no longer normal to the rod axis. The void-like features occur because the cuboids tilt into the observation surface, and at many locations small segments were extracted during preparation. The micrograph in Figure 8 shows the changing crack patterns. On the left is a typical diffraction pattern from location "A" and the related stereogram. The dot is the pole of the observation surface, and the (100) plane is horizontal and nearly normal to the observation surface. On the right are (upper) the stereogram for region "B" and a sequence of stereograms from a traverse across the transition region "C." The accompanying typical diffraction pattern corresponds to the "double" stereogram plotted from the opposite ends of each elongated diffraction spot. The orientation of the crack patterns in the transition region can be seen to change in parallel with the (100) trace in the stereograms, which indicate (as does the shape of the spots) a single-axis rotation about the observation normal.

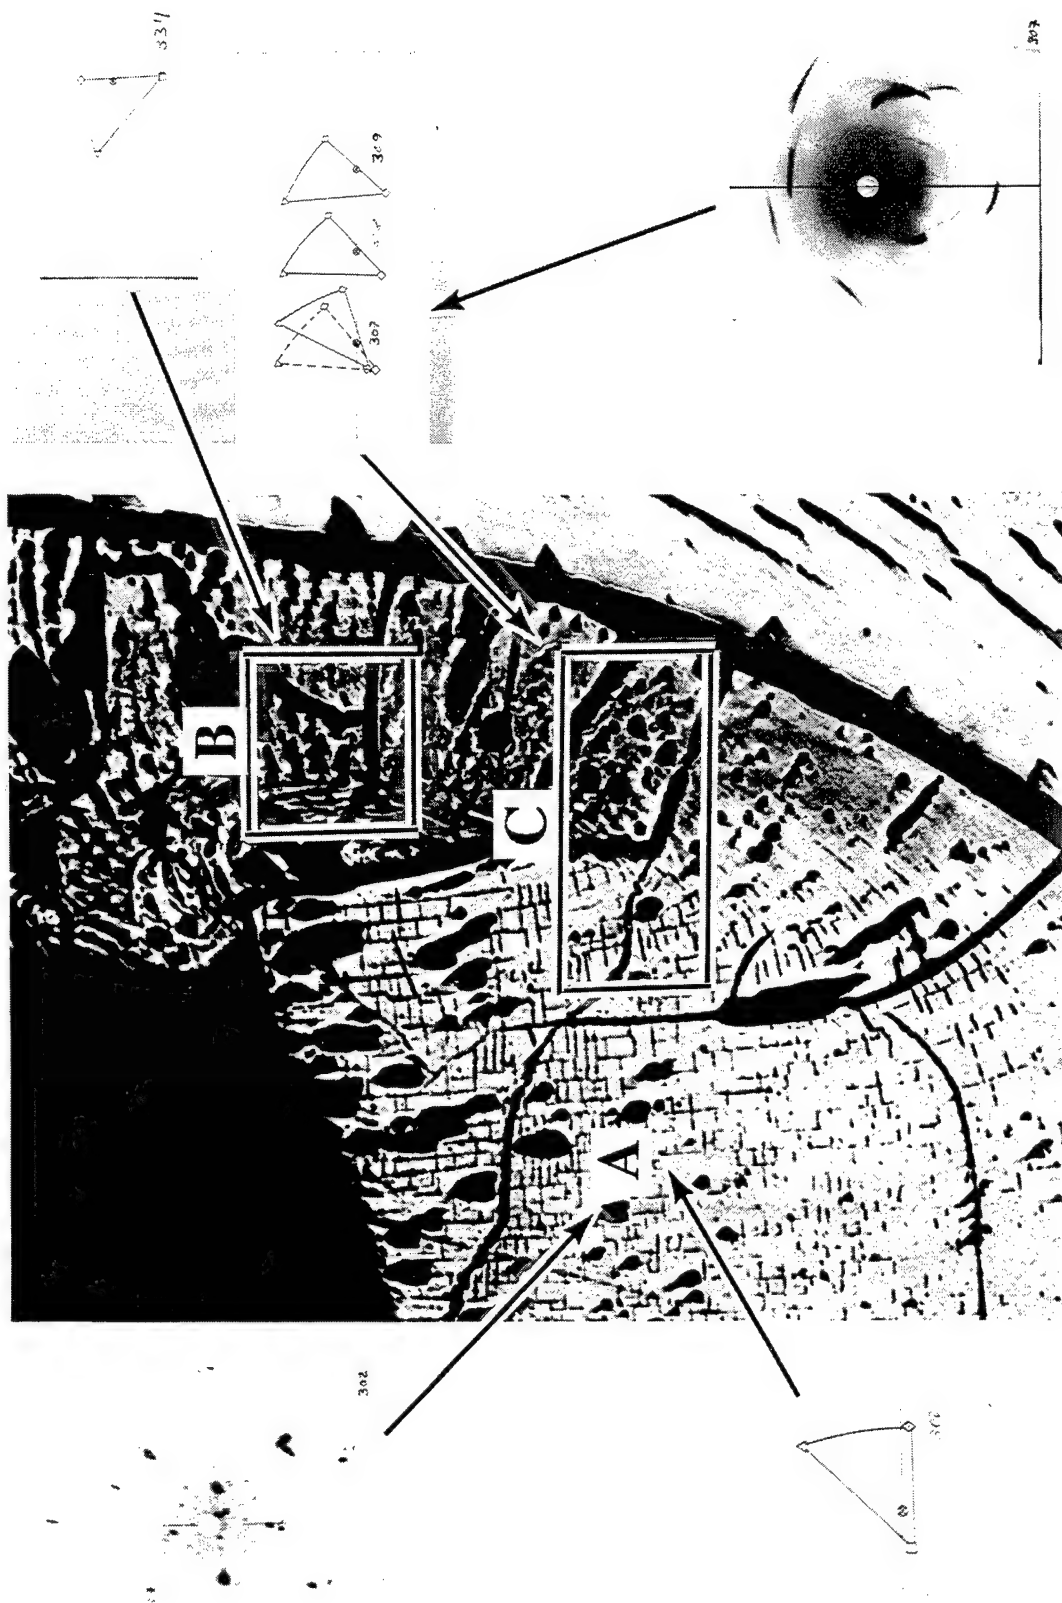
Figure 8. Partial Axial Section of [100] Penetrator With Orientation Analysis for Selected Regions.

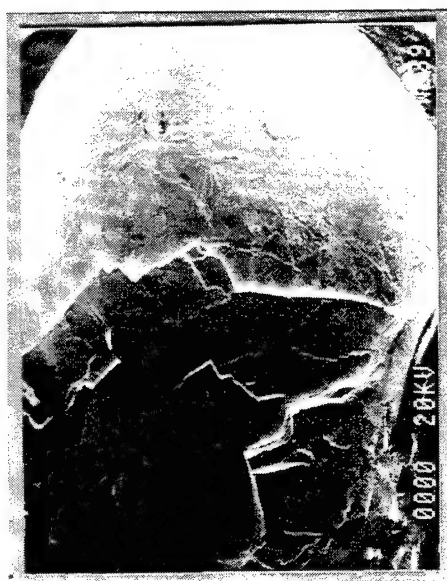
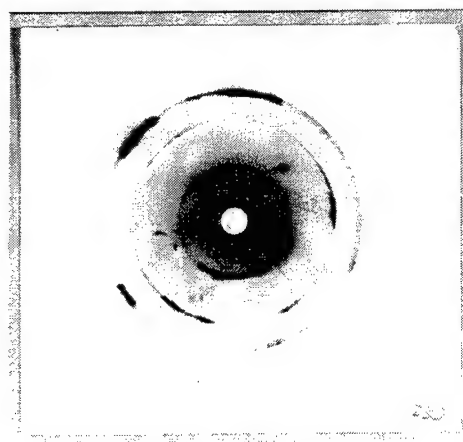
Figure 9. Convex Surface of [100] Penetrator Fragment (nose down): (a) Overview; (b) Tabular Packets; (c) Diffraction Pattern.

Examination of a second [001] penetrator further elucidated the nature of this rotation and the true three-dimensional character of the deformation process. This penetrator cracked during flight and impacted the target in two closely spaced coaxial segments, and thus the residual did not have full integrity. After sectioning, most of the residual dropped out intact, leaving a partial shell of deformed layers adhered to the concave surface at the bottom of the penetration tunnel in the target block. Figure 9a is a scanning image of the convex surface of this extracted fragment at low magnification (nose pointed down). The convex surface appears covered with tabular rectangular packets, often rotated relative to one another (Figure 9b). Although a thin surface layer was deformed and partially recrystallized, discrete diffraction spots were distinctly visible in these packets (Figure 9c). It appears that material flow in the [001] crystals is not purely radial but that the flow packets of {001} layers also have a rotational degree of freedom about the normal to the packet. This would imply a very substantial degree of independence for these entities after cleavage. The rectangular edges of the packets also appear to be defined by {001} cleavage planes, but this could not be directly confirmed.
